Dual-View Imaging Report

750 My Street
Cincinnati, Oh 45245

Date: Oct 7, 2013

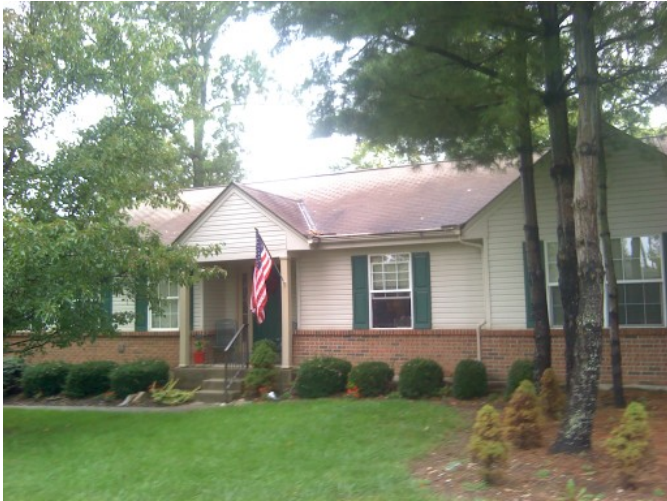
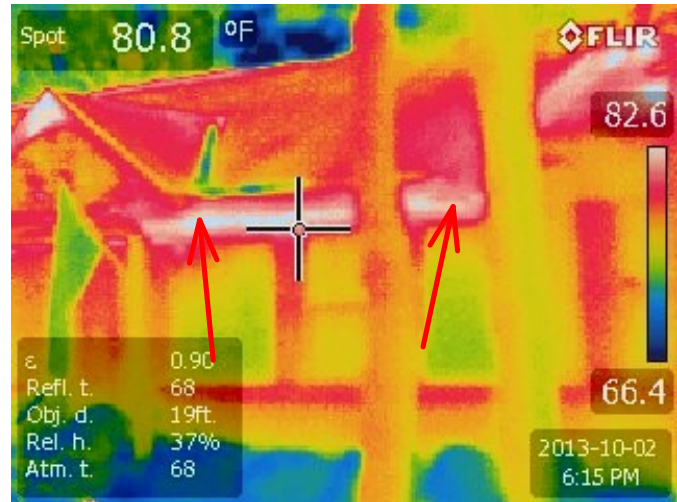
Location Floor: Front Elevation
 Location Direction: East
 Equipment: x50bx

Observations:
 Heat being forced out of the attic , by the attic fan which is on.

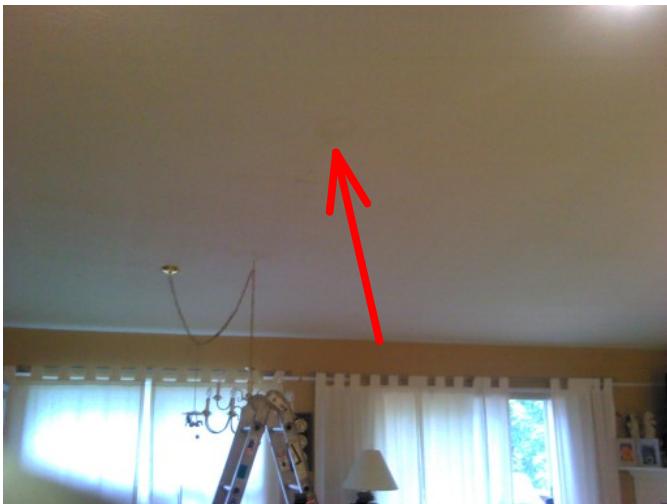
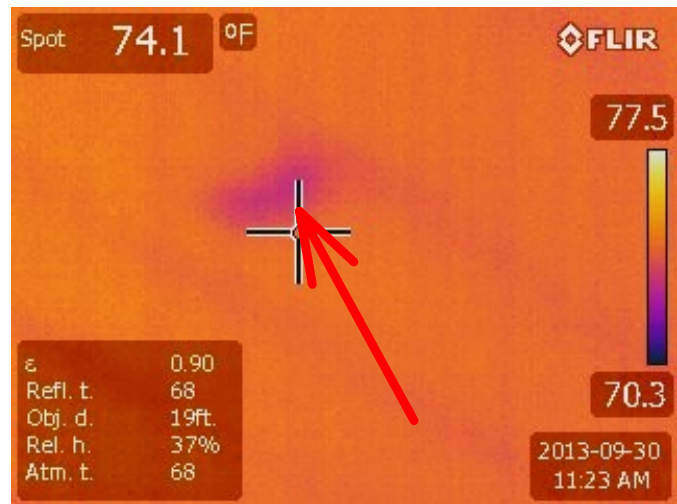
Location Floor: 1st floor dining room ceiling
 Location Room: Dinning room ceiling
 Equipment: e50bx and moisture meter

Observations:
 Water staining was noted at the ceiling. Ir identified a tempature difference and a moisture meter varified the ceiling was wet.

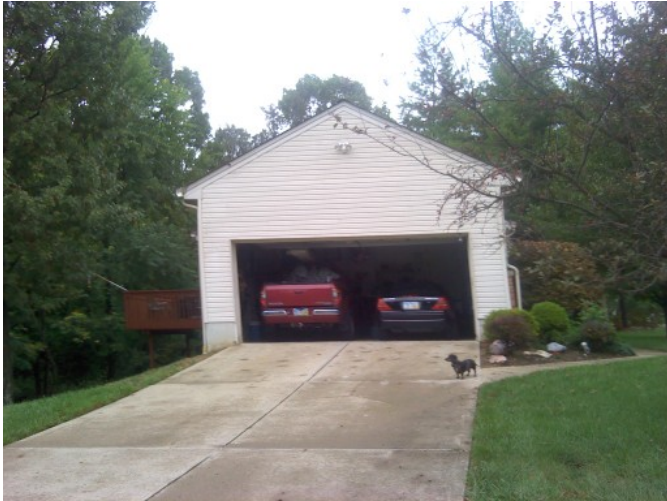
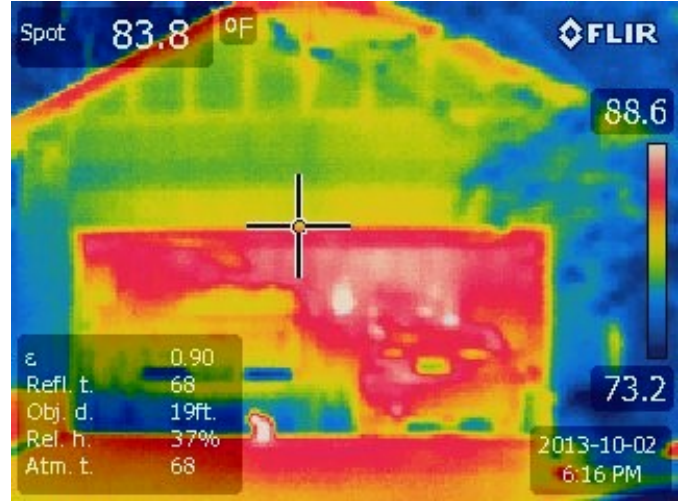
Location Floor: Garage
 Location Direction: South
 Equipment: x50bx

Observations:
 Heat generated by a car that was driven into the garage

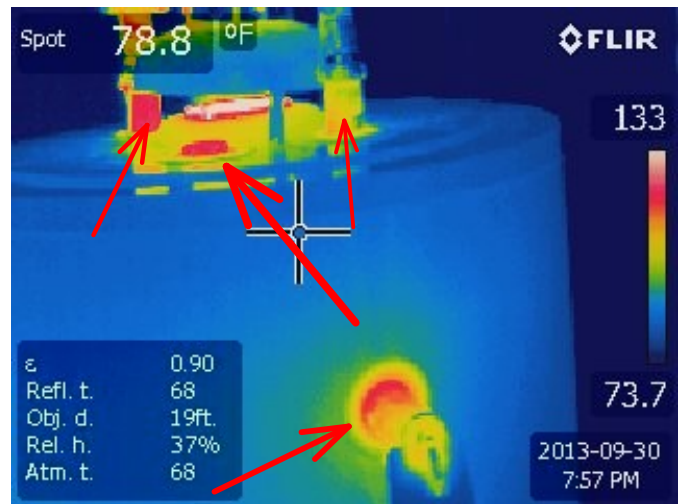
Location Floor: Basement
 Location Room: Utility
 Equipment: x50bx

Observations:
 Hot and cold water lines and TPR valve.

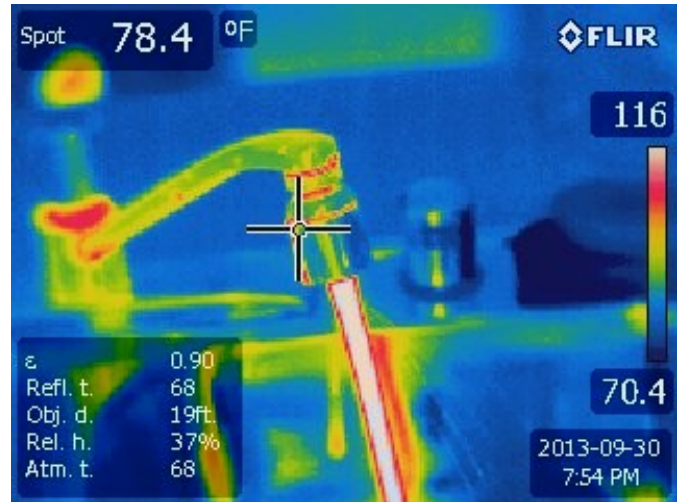
Location Floor: 1st Floor
Location Room: Kitchen
Equipment: x50bx

Observations:
Water faucet temperature.

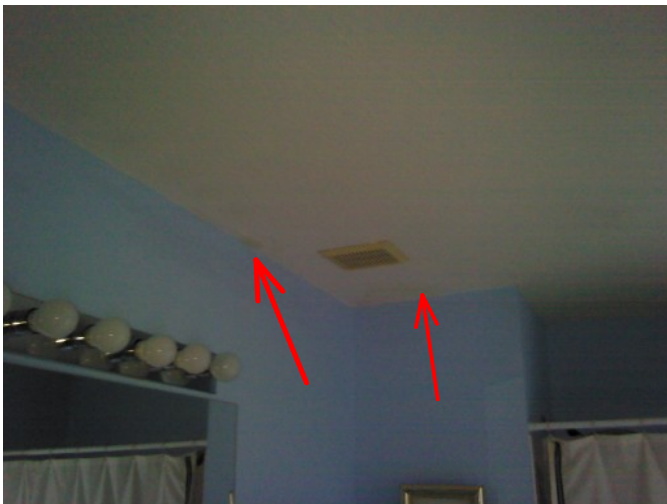
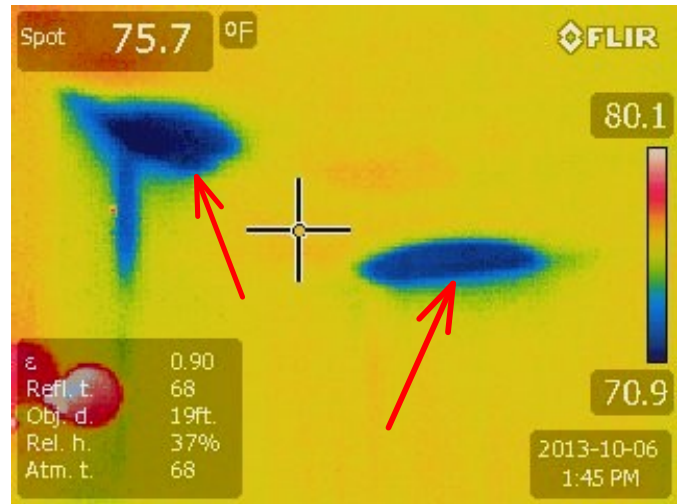
Location Floor: 1st floor
Location Room: Master bathroom
Equipment: x50bx

Observations:
Moisture staining was noted at the ceiling in two places. The roof appears to be leaking

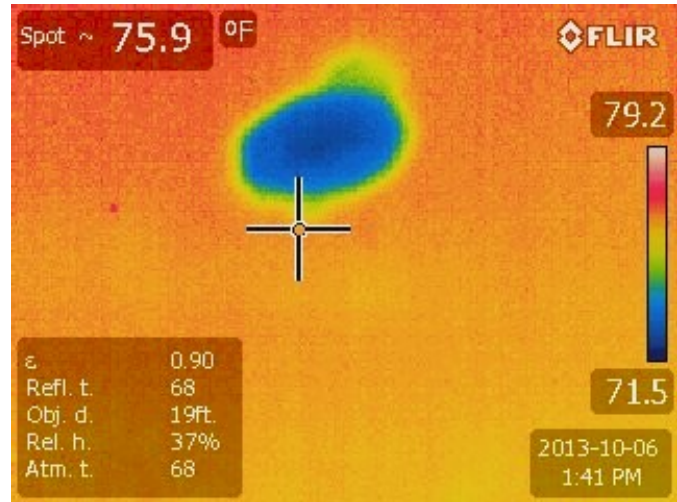
Location Floor: 1st floor
Location Room: Master bathroom

Observations:
Moisture at the Master bathroom ceiling.

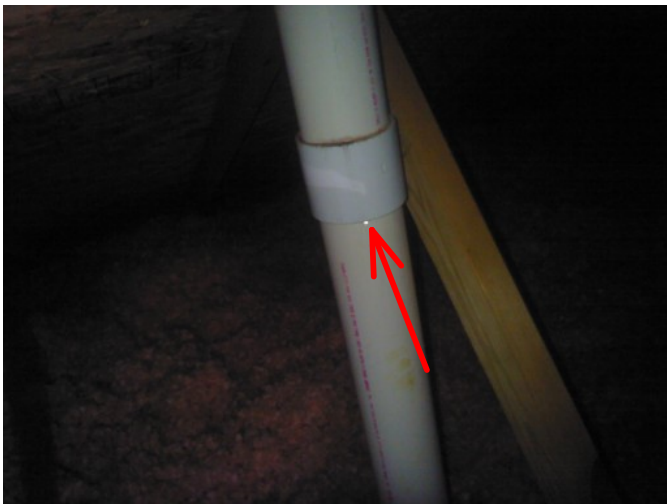
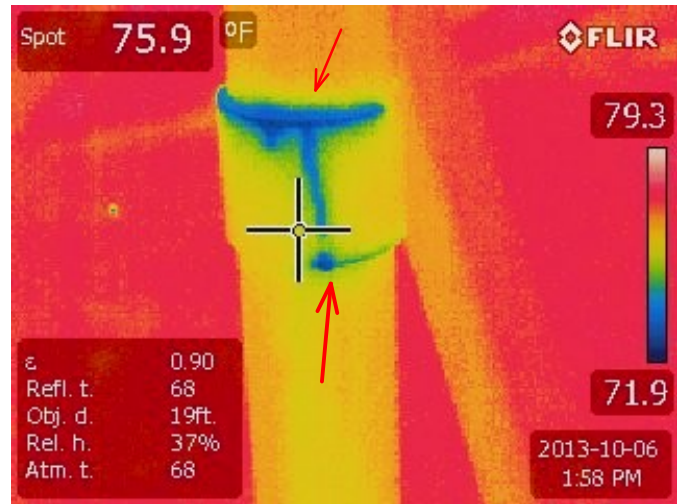
Location Floor: Attic

Observations:
Water noted at the vent pipe. It appears to be from a roof vent boot leak

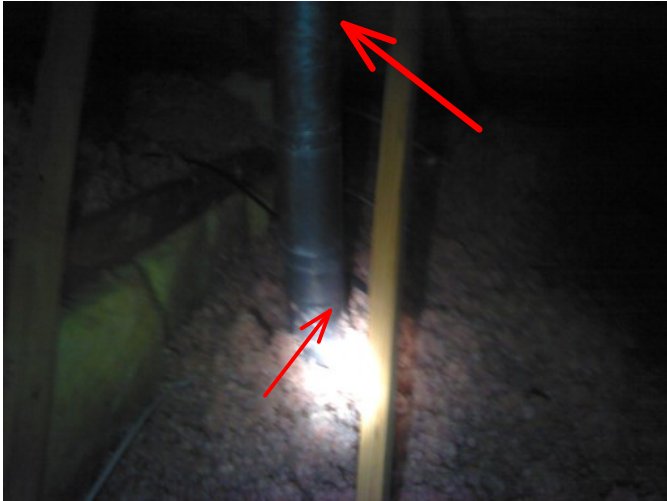
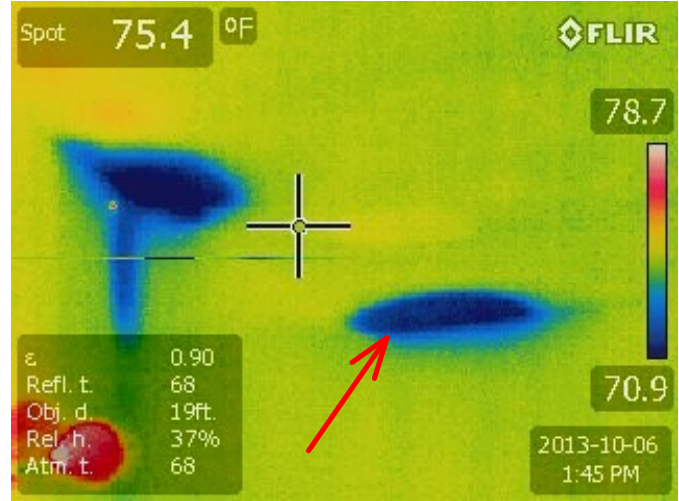
Location Floor: Attic

Observations:
Leaking around the furnace flue pipe , leaking on the master bathroom ceiling.

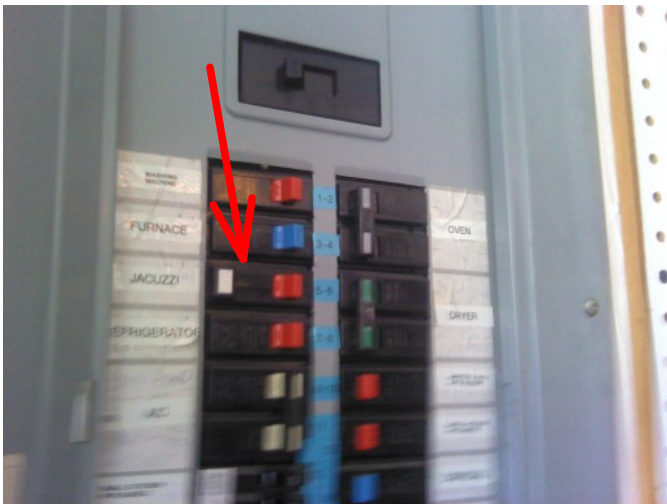
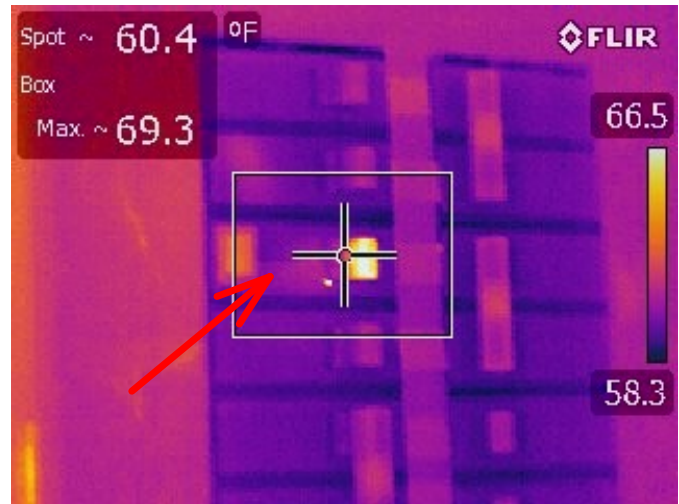
Location Floor: 1st floor
Location Room: Garage
Equipment: x50bx

Observations:
The electric consumed at a GFCI
